Product	ESC Velocity
Currawong part number	CE1101
Bulletin issue date	26 November 2018
Serial numbers range	n/a

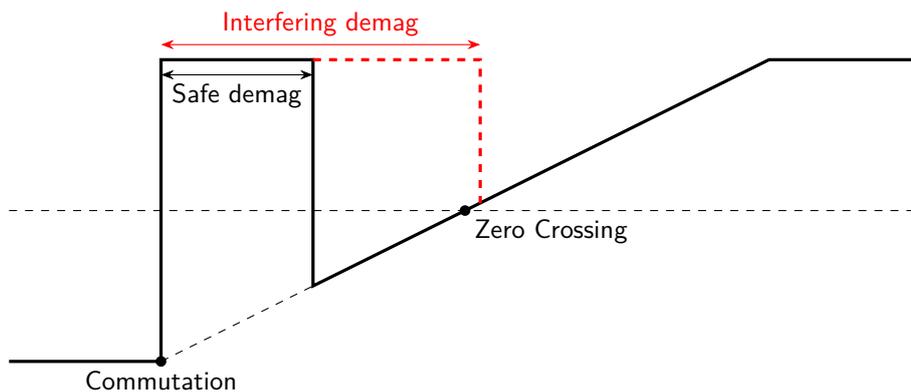
The ESC uses the back EMF of the unenergised motor phase to estimate rotor position. When the motor commutates to the next active phase, the energy in the now inactive phase must be dissipated. This 'demagnetisation' current creates a large noise pulse in the measured back EMF.

If the width of the demag pulse becomes large enough, it may overlap with the zero crossing point and cause a 'desynchronisation' event where the ESC is unable to commutate to the next phase correctly.

This behaviour will only occur for some combinations of motor, propeller and operating power point. In many existing applications it may be avoided by increasing the timing advance parameter, which will result in commutation occurring further ahead of the zero crossing and hence providing more time for the demagnetisation current to dissipate.

Motor control firmware 3.19 and above introduces a new feature that measures the demagnetisation time each commutation. If the demag time approaches the threshold at which desync might occur, the ESC automatically winds back the duty cycle. At this point no additional power will be delivered to the motor even if the commanded duty cycle increases, however the chance of a desync will be greatly reduced.
