Power4Flight Product Advisory

B100i Throttle Linkage - Inspection and Update Procedures

Date: 7/15/2021

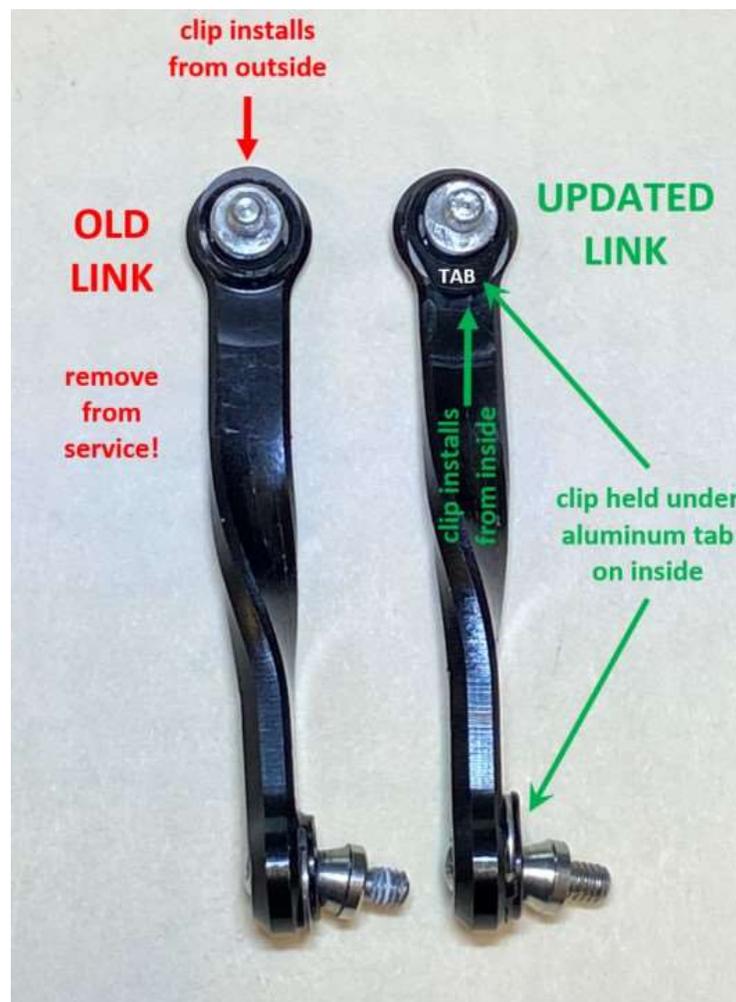
About a year ago a customer had a linkage failure and we put out an inspection directive and began tracking the issue. Ongoing inspections were showing some wear on the arms from the clips due to high vibration which we now believe was the cause of the first failure. Subsequently, Power4Flight and Cobra decided to change the retaining clip configuration (see photos below) to minimize wear and improve overall retention and linkage robustness. This change was made and deployed on all new engine deliveries, prior to the second documented failure. The second failure that occurred was on an engine that should have been inspected and potentially updated if the inspection showed wear. The second failure is being attributed to wear from vibration between the hard steel retaining clip and the soft aluminum arm that we believe allowed the retaining clip to rotate and fall out – consistent with the first incident. The second failure happened even though we had implemented an inspection protocol and had a new replacement linkage available. Given we have experienced a second failure with the added inspections measures in place dictates that we need to remove all old-style linkages from service.

The new linkages, that were deployed after the first incident, hold the clip from the inside of the arm which limits the potential clip movement and to date seem to show less wear. We have had no failures with the new-style (current) arm. There is always room for improvement, so we are looking at further mitigation measures on the current arms that we plan to roll out once properly tested and validated. Until then we recommend that:

The first step for all B100i engine customers is to identify which linkage configuration you have installed on each engine. The diagram below shows the two versions side by side – the old-style is shown on the left and the current version is on the right. If you have an old-style linkage installed, we recommend that you contact Power4Flight so we can get you a replacement linkage assembly. **We do not recommend flying the old-style linkages given we have seen a second failure.**

If you have the current or second-generation arm on your throttle linkage assembly, we would like you to visually inspect prior to flying to make sure that there is no unusual wear or other potential issues. If anything looks unusual or different than expected, contact Power4Flight to discuss.

1. Any engine with the old-style linkage be identified, inspected and grounded.
2. All old-style arms be removed and replaced with the current version before being returned to flight.
3. All engines with the current version of the linkage be inspected before returning to flight.

Once the suspect arms have been identified we will supply a kit and procedure for replacing them. The removal/replacement is simple and requires no adjustments, just the removal of the two ball link screws and old arm and the insertion of the replacement arm with ball links attached.
